PROCEEDINGS OF THE
MERCHANT MARINE COUNCIL

December 1947

Federal Court Decides Radar Collision

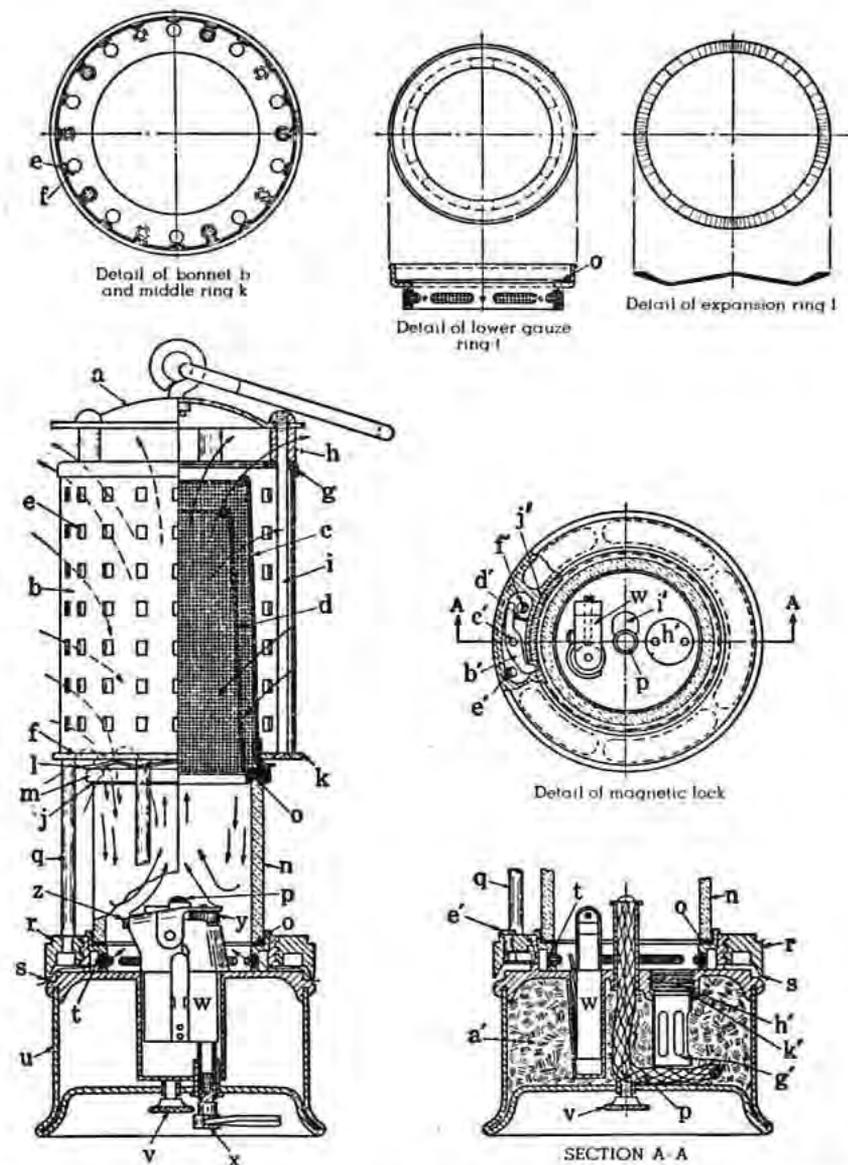
FIGURE 1.—Details of Koehler lamp: *a*, Hood; *b*, bonnet; *c*, outer gauze; *d*, inner gauze; *e*, louvers; *f*, air inlet holes; *g*, stiffening ring; *h*, spacer sleeves; *i*, assembly rods; *j*, gasket ring; *k*, middle ring; *l*, expansion ring; *m*, gauze ring; *n*, lamp glass; *o*, asbestos gaskets; *p*, wick; *q*, guard rods or standards; *r*, bottom or lock ring; *s*, baffle; *t*, lower-gauze ring; *u*, fuel fount; *v*, wick adjuster; *w*, relighter; *x*, relighter handle; *y*, friction or file wheel; *z*, spark-adjustment screw; *a'*, absorbent cotton; *b'*, lock dog; *c'*, lock-dog pivot; *d'*, lock spring; *e'* and *f'*, magnet contacts; *g'*, cotton spreader; *h'*, filling plug; *i'*, adjustment screw cap; *j'*, lock recesses; *k'*, filling-plug gasket.

Details of the Koehler and Wolf round-wick lamps are shown in figures 1 and 2, respectively. The corresponding flat-wick models differ only in the shape and position of the wick tube. Additional details of all the lamps are given in table 1.

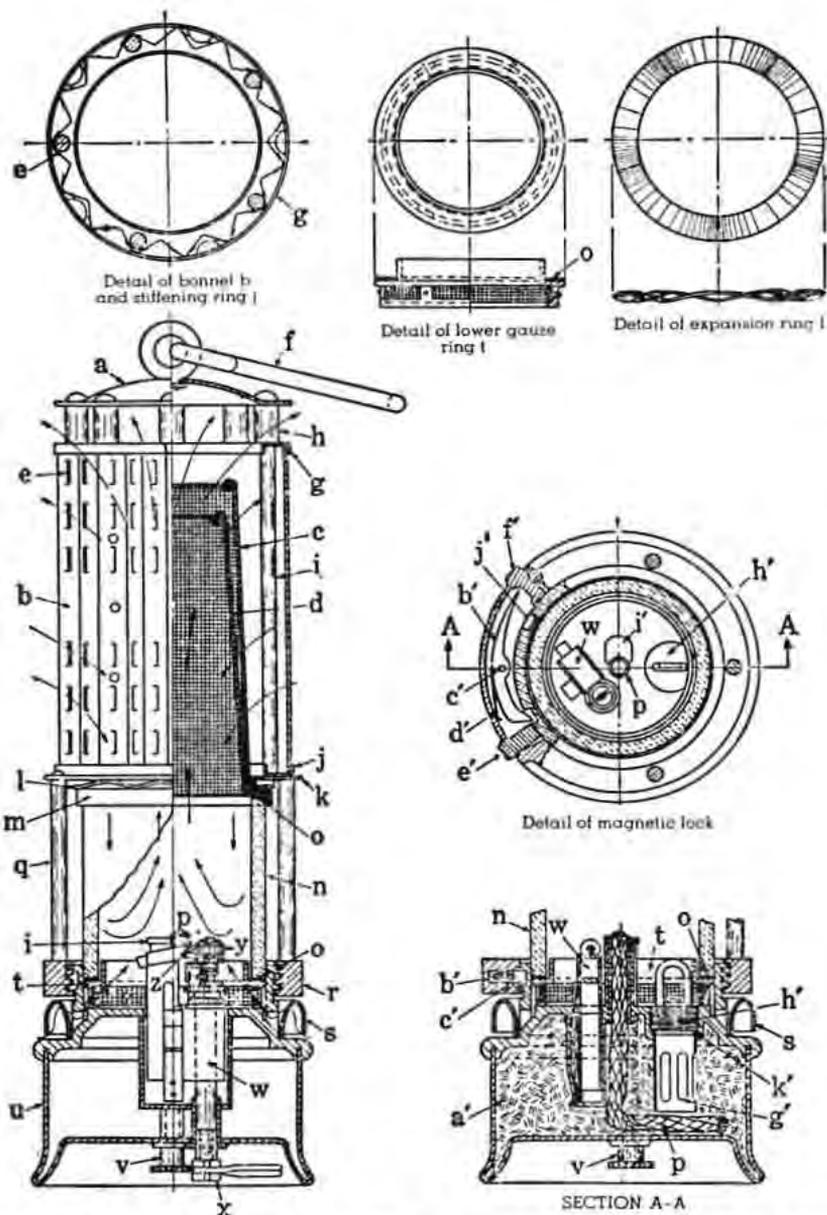
FIGURE 2.—Details of Wolf lamp: a, Hood; b, bonnet; c, outer gauze; d, inner gauze; e, louvers; f, ball; g, stiffening ring; h, spacer sleeves; i, assembly rods; j, lower stiffening ring; k, middle ring; l, expansion ring; m, gauze ring; n, lamp glass; o, asbestos gaskets; p, wick; q, guard rods; r, bottom or lock ring; s, baffle ring; t, lower-gauze ring; u, fuel fount; v, wick adjuster; w, relighter; x, relighter handle; y, friction or file wheel; z, cerium spark pin; a', absorbent cotton; b', lock dog; c', lock-dog pivot; d', lock spring; e' and f', magnet contacts; g', cotton spreader; h', filling plug; i', adjustment-screw cap; j', lock recesses; k', filling-plug gasket.

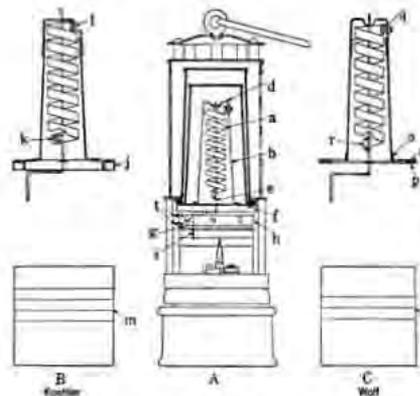
FIGURE 3.—Details of improved lamp.

The Koehler and Wolf round-wick permissible lamps may be equipped with a bimetal device as shown in figure 3; they then are designated as "improved" lamps.

The bimetal unit is a strip of bimetal, *a*, $\frac{3}{32}$ inch wide and 0.005 inch thick, wound as a helix and mounted in a stainless-steel tube, *b*. The top of the helix is attached to yoke *d* and the bottom to pointer rod *e*. The tube is spot-welded to spider *f*, which permits its assembly in the inner gauze as shown in figure 3, A.

The unit is used with scale *g*, which has a translucent part, *h*, through which the shadow of pointer extension

i is visible; a special glass with etched parallel lines permits setting the flame at a definite height. The unit is applied to round-wick lamps only because the wick tube in all flat-wick lamps is off-center; this eccentricity and the irregular shape of the flame give erratic heating of the bimetal and an unsatisfactory shadow of the pointer.

The bimetal-helix units as approved with the Koehler and Wolf lamps are identical, but details of the mountings are different, as shown in figure 3, *B* and *C*, respectively. The spider of the Koehler unit is fitted with gasket ring *j*, which is mounted with the gauzes in the regular way. The bimetal is riveted at *k* and *l*. The latter

purposely is left loose to permit freedom of alignment as the helix operates. Four parallel lines spaced one-fourth inch apart are etched on the inside of the Koehler glass. The position of the lines is such that when the flame tip is at the second line *m* it is about fifteen-sixteenths inch high. The top line is covered by the scale when used with the bimetal unit.

Rim *n* of the Wolf unit is a flat stainless-steel disk connected by four arms to spot-welded collar *o*. When the unit is assembled this disk is placed next to the rim of the inner gauze, with an asbestos gasket, *p*, at the bottom next to the glass. The bimetal is held loosely at the top by bolt *q* and is fastened at *r* by a loop in the pointer rod. Three parallel lines are etched on the outside of the Wolf glass. When the flame tip is at the second line *s* it is about seven-eighths inch high.
